Ouzinkie Health Clinic

Alaska Rural Primary Care Facility

Assessment and Inventory Report

February 24, 2004

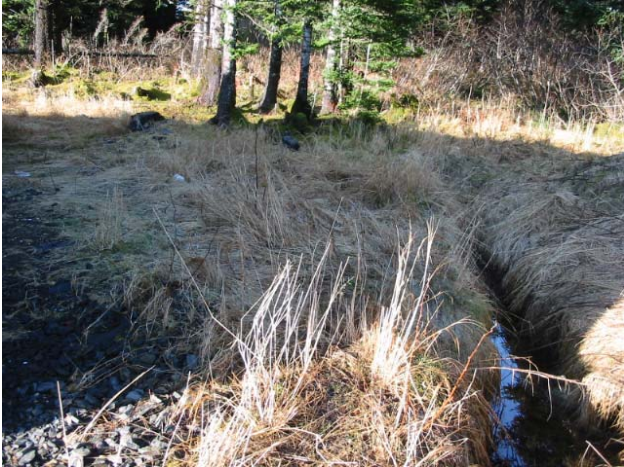
Civil Deficiencies			
Item #	Code	Deficiency	Suggested Resolution & Rough Order of Magnitude Cost Estimate
Cou01	08	Drainage ditch hasn't been maintained and isn't performing effectively.	Provide effective grading leading to drainage ditch, clean site to allow for drainage and maintain ditch to enhance performance. (\$1600)
Cou02	08	Standing water at base of stairs, ramps and in parking areas.	Provide effective grading to allow water to drain into existing ditch. The estimated cost for this deficiency is included in Cou01.
Cou03	02	Lacking signage or parking designations, so vehicles are often parked directly in front of main entrance.	Designate handicap parking and signage. (\$1000)
Cou04	08	Standing water on site.	Provide effective grading to allow water to drain into existing ditch. The estimated cost for this deficiency is included in Cou01.
Architectural Deficiencies

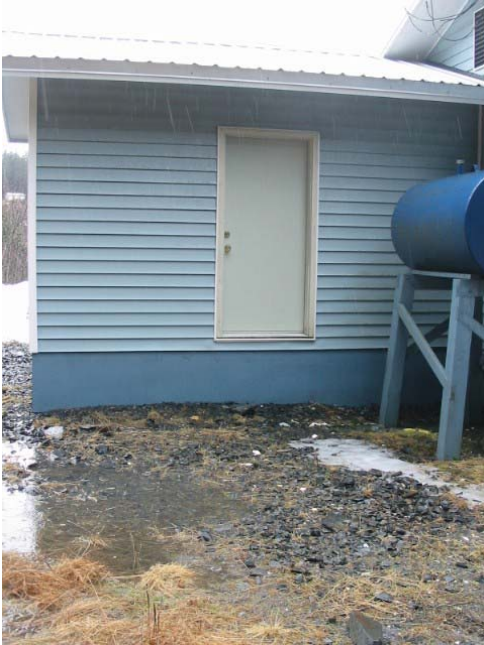
Architectural life safety issues appear to be minimal; however there are several disability access deficiencies that can result in life safety concerns. The major exits from the Ouzinkie Health Clinic provide inadequate or no egress for those with disabilities. There is equipment stored in the only accessible egress route (*Aou18*). There is an exterior door leading from the storage room that has no landing, stair or ramp; the drop from finish floor to grade is 3'-0" (*Aou01*).

Item #	Code	Deficiency	Suggested Resolution & Rough Order of Magnitude Cost Estimate
Aou01	03	Exterior door from storage room has no means of reaching grade ie: landing, stairs or ramp.	Construct ADA compliant landing with attached stairs and compliant railing. (\$3000)
Aou02	02	Only available ramp is not ADA compliant. The slope exceeds 1:12, there is no landing at the top of the ramp, the railing doesn't have 12" extensions at top and bottom and the rise from grade to ramp surface exceeds ¼".	Construct an ADA compliant ramp. (\$25,000)
Aou03	03	Emergency vehicle access landing is less than the 8'-0" required for stretcher access.	Replace landing with an 8'-0" landing. The estimated cost for this deficiency is included in Aou02.
Aou04	02	The ramp and all of the stairs are lacking ADA compliant handrails.	Install ADA compliant handrails. The estimated cost for this deficiency is included in Aou02.

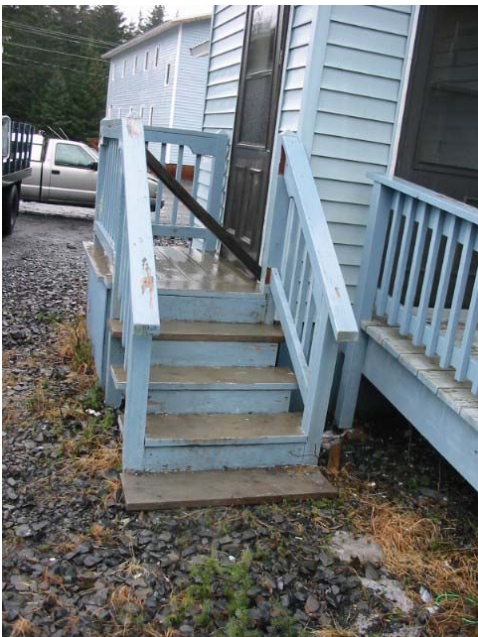
Aou03

Overall the facility is lacking adequate space for many of its current functions and is completely missing some rooms that are needed. Specifically, the trauma room is undersized (*Aou20*) and inaccessible to stretcher access (*Aou03*); the present restroom isn't ADA compliant (*Aou17*) and there should be two compliant restrooms; there is no secure records storage (*Aou12 & Aou14*) nor is there adequate administrative office space (*Aou19*); there is not provision for traveling health professionals in either sleeping space or work space (*Aou08, Aou09 & Aou10*); and there is no space for specialty clinics or health education. Additionally, there is no emergency eye wash in the facility (*Aou29*). The clinic can also be improved functionally. (See Proposed Additions A6 & A7)

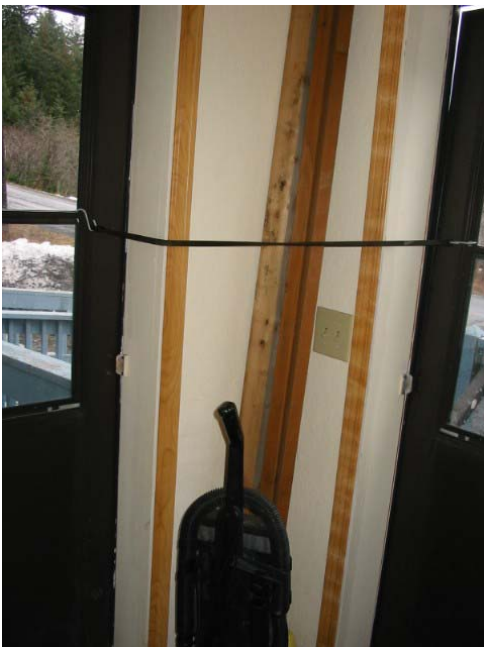
Aou06	03	Stair/landing to mechanical room has deteriorated to the point of being dangerous.	Replace mechanical room access landing and stair with pre-manufactured "ships" ladder. (\$750)
Aou07	02	The only entry that has an accessible ramp is locked off from public use.	Remove ramp and construct an ADA compliant ramp at the main entry. The estimated cost for this deficiency is included in Aou02.
Aou08	03	Hallway is used for storage and work space for visiting health professionals.	Expand and add designated work space for visiting health professionals. Note: This deficiency is the first of many that necessitate a major addition / alteration to resolve. The costs associated with this deficiency are based on ROM square footage estimates for new and existing alterations. Refer to Section 7.5 for a breakdown of new/renovation construction costs, for this and all remaining deficiencies unless otherwise noted.

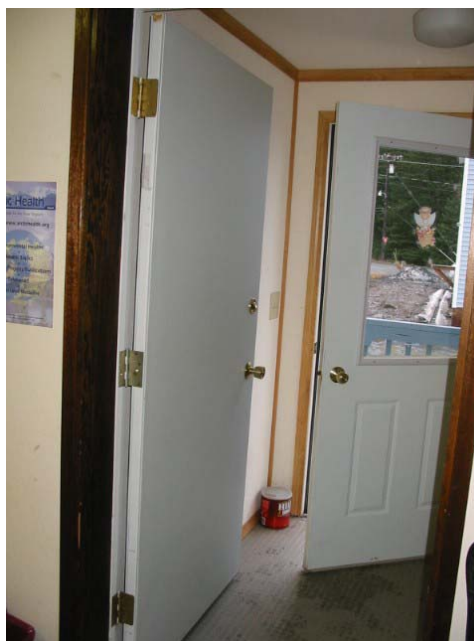
Aou21	02	The Arctic entry for the main entrance isn't ADA compliant. The door swings are incorrect and there isn't 4'-0" clear between the door swing and the wall.	Expand Arctic entry and correct door swings.
Aou22	02	Exterior doors do not have ADA compliant lever handles.	Replace exterior door hardware with ADA compliant hardware.
Aou23	02	Interior doors do not have ADA compliant lever handles.	Replace interior door hardware with ADA compliant hardware.
Aou24	03	Trim around doors and some windows is deteriorating.	Repair and repaint trim.
Aou25	03	Reception window needs to be finished with trim and a sill. Walls have some scuffing and need refinished.	Install trim and sill around reception window.
Aou26	03	Insulation is inadequate in attic space. Insulation is missing in parts of the attic, esp. around mechanical ductwork. Overall the attic is deficient in insulation by at least 6".	Replace missing insulation and install additional insulation.

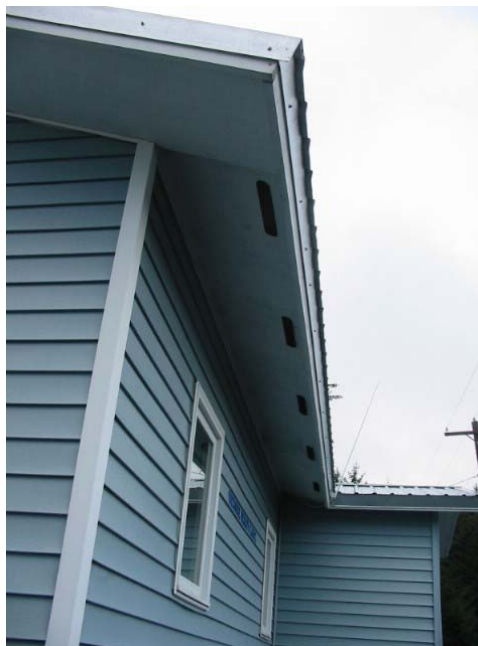
Aou27	03	Soffit venting is inadequate. Venting only	Install continuous soffit vents.

occurs at every other truss space rather than continuously.	
Aou28	03	Baffling is only present in every other truss space.	Install baffles in every truss space.
Aou29	03	Emergency eye wash station is missing.	Install Emergency eye wash station.
Mechanical Deficiencies

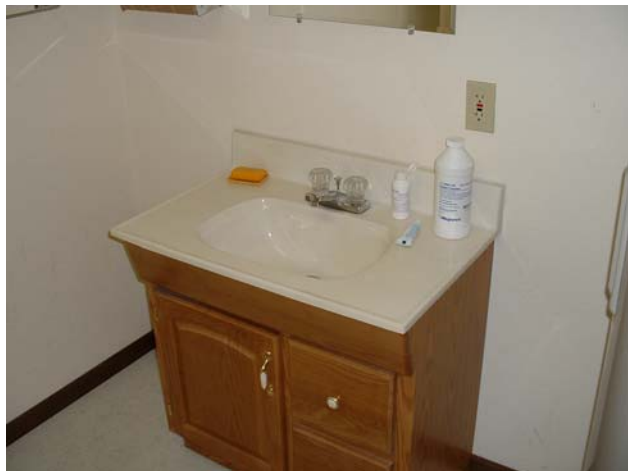
Item #	Code	Deficiency	Suggested Resolution
Mou01	05	Plumbing fixtures are residential, not commercial type.	Replace fixtures.
Mou02	05	Water closet seats are closed front, not split front.	Replace seats.
Mou03	05	Hot water heater not seismically restrained.	Strap to wall.
Mou04	05	Shower valve not pressure balancing.	Replace valve.
Mou05	05	Fixtures plumbed with S-traps.	Replace with P-traps.
Mou06	05	Plumbing fixtures not vented.	Re-pipe all fixtures with individual vents.
Mou07	05	Cleanouts not provided in waste piping.	Provide cleanouts at upper end of all waste pipe runs.
Mou08	05	No over-fill protection at fuel oil tank.	Provide 3.5 gallon over-fill container on fuel tank fill connection.
Mou09	05	Fuel oil supply pipe inadequately supported.	Provide additional pipe support(s).
Mou10	01	Fuel oil safety valves not provided.	Provide fusible valve and oil safety valve.
Mou11	05	Return air pulled from toilet room.	Revise return air system, cap duct at toilet room.

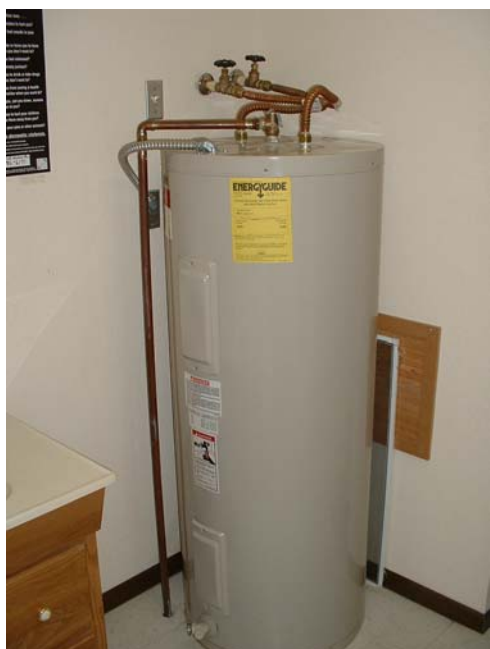
Mou03

Hot water is provided by a single electric water heater with 50-gallon capacity and 4,500-watt input rating. The water heater is located in the toilet room. It does not have any seismic restraints, a violation of the plumbing code (*Mou03*). The pressure relief valve is fitting with a discharge pipe routed through the floor to discharge into the crawlspace. The water heater does not have an expansion tank with check valve on the cold water line to ensure constant pressure in the tank.

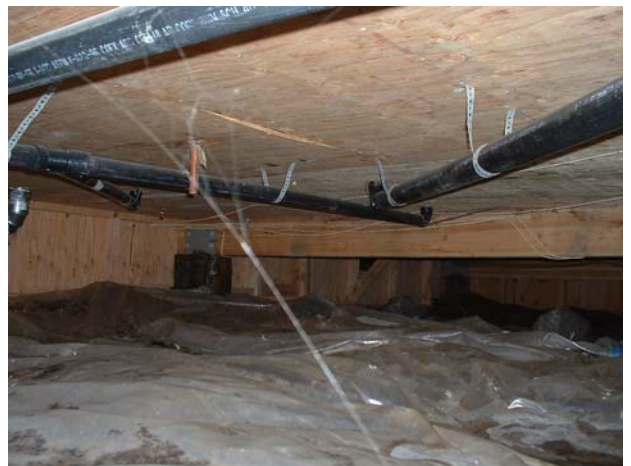
Mou08

The building uses fuel oil for service to the heating system. The fuel tank, a single wall type, is located directly adjacent to the building. The tank is located on a 5-foot high stand. The tank capacity is approximately 500 gallons and appears to be in good condition. However, there are no provisions for spill prevention (such as an overfill containment basin on the fill), no tank fuel level gauge, and the bottom-outlet fuel supply piping is inadequately supported (*Mou08 & Mou09*).

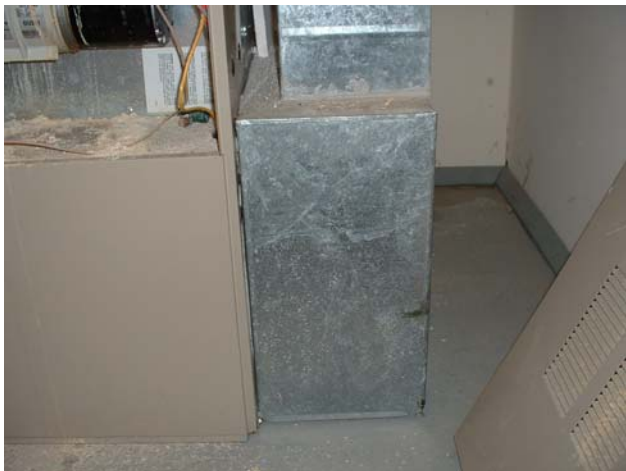
Return air is pulled from the toilet room, a situation prohibited by the mechanical code (*Mou11*). A duct open to the cold, ventilated attic space intersects with the main furnace return air, presumably for supplying outside air for ventilation, although this is not recommended. The duct opening is not screened. The outside air duct should extend directly to the exterior to avoid pulling any fiberglass particles (from the fiberglass batt roof insulation) into the duct system (*Mou12*). In addition, there are no balancing dampers to control the amount of outside air. Too much outside air will lower the temperature of the air returning to the furnace which can, over time, damage the heat exchanger, as well as imposing a larger heating load than necessary on the furnace (*Mou13*).

Mou12	05	Outside air duct terminates in attic.	Extend duct to louver on exterior wall.
Mou13	05	No balancing dampers on return or outside air ducts.	Provide dampers.
Mou14	05	No filter in furnace system.	Install filters in return air.
Mou15	01	Furnace flue corroded.	Replace with double-wall flue.
Mou16	01	Flue clearances to combustibles not maintained.	Replace with new flue, installed per manufacturer's requirements.

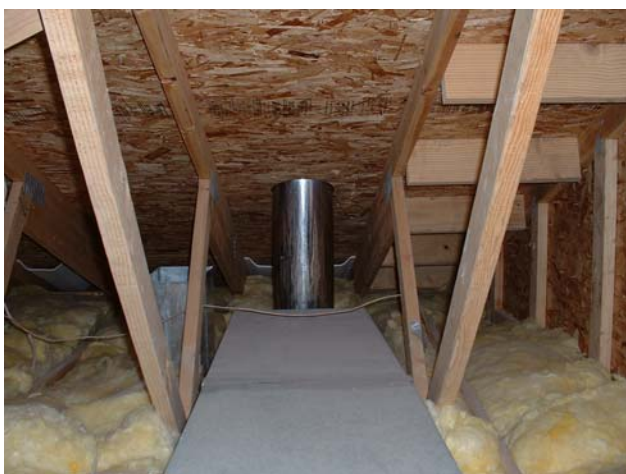
Mou15

The return air side of the furnace does not have a filter (*Mou14*). The furnace flue is a single-wall pipe and is corroded to the point where replacement is recommended (*Mou15*). The flue does not have an insulation shield at the roof penetration, nor does it have adequate clearance to combustible wood construction as required by code (*Mou16*).

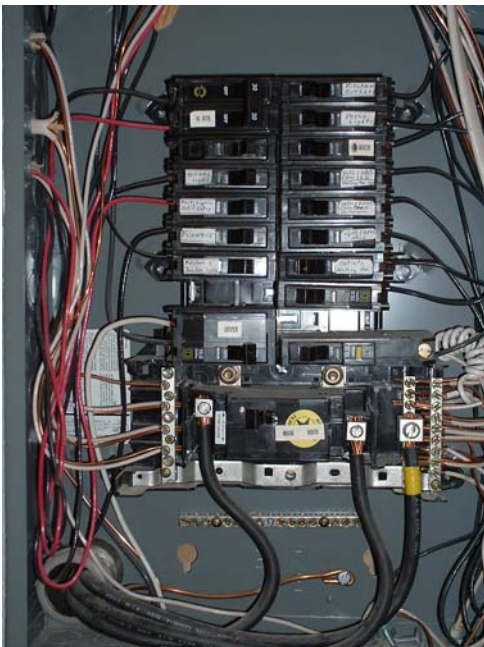
Item #	Code	Deficiency	Suggested Resolution
Eou01	01	Separation of electrical disconnect from fuel tank inadequate.	Relocate fuel tank.
Eou02	06	Grounding and neutral bus bars tied together.	Re-wire panel to connect ground wires to ground bus bar.
Eou03	06	Clearance in front of electrical panel is inadequate.	Relocate clothes washer/dryer.
Eou04	06	NM (Romex) cabling used in patient care areas.	Replace NM cable with wiring routed in conduit.
Eou05	06	Junction boxes in attic missing covers.	Provide covers.
Eou06	06	Quantity of receptacles inadequate.	Provide additional receptacles where needed.
Eou07	01	Emergency light missing.	Replace missing light and provide an additional emergency light.
